# UNDERWATER BRIDGE INSPECTION REPORT

STRUCTURE NO. 66520  
TWNS NO. 51 (220<sup>th</sup> STREET)  
OVER THE  
STRAIGHT RIVER  
DISTRICT 6 - RICE COUNTY

PREPARED FOR THE  
MINNESOTA DEPARTMENT OF TRANSPORTATION  
BY  
COLLINS ENGINEERS, INC.  
JOB NO. 5221

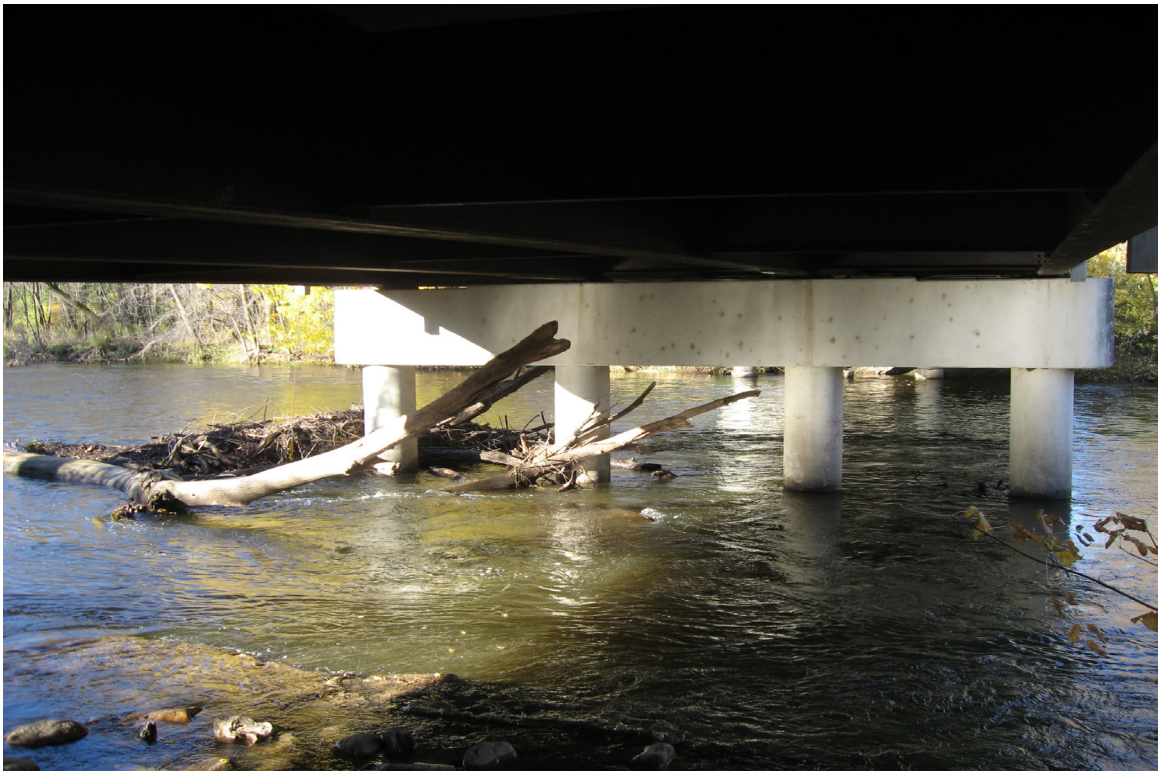
Photograph 2. View of Pier 1, Looking West. Note the heavy accumulation of timber debris.

- 1 A heavy accumulation of 2-foot-diameter and smaller timber debris was observed at the two upstream columns and the downstream column of Pier 1 that extended from the channel bottom up to 3 feet above the waterline.

The heavy accumulation of timber debris at Pier 1 should be removed during routine maintenance.

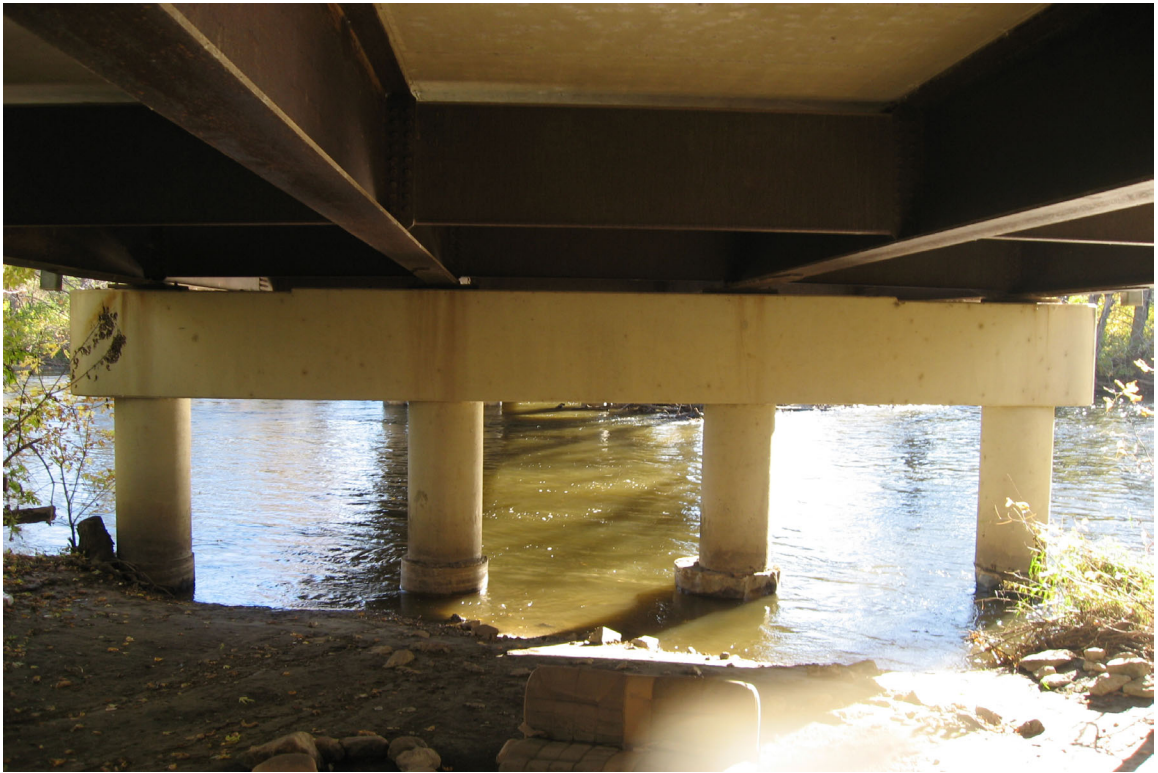
Photograph 3. View of Pier 2, Looking East.

- 3 The tops of the concrete encasements at Pier 2 were typically located 6 to 10 inches above the waterline. The encasements varied in thickness from 1 to 6 inches with respect to the face of the columns and exhibited form irregularities (embedded form boards) with up to 6 inches of penetration.

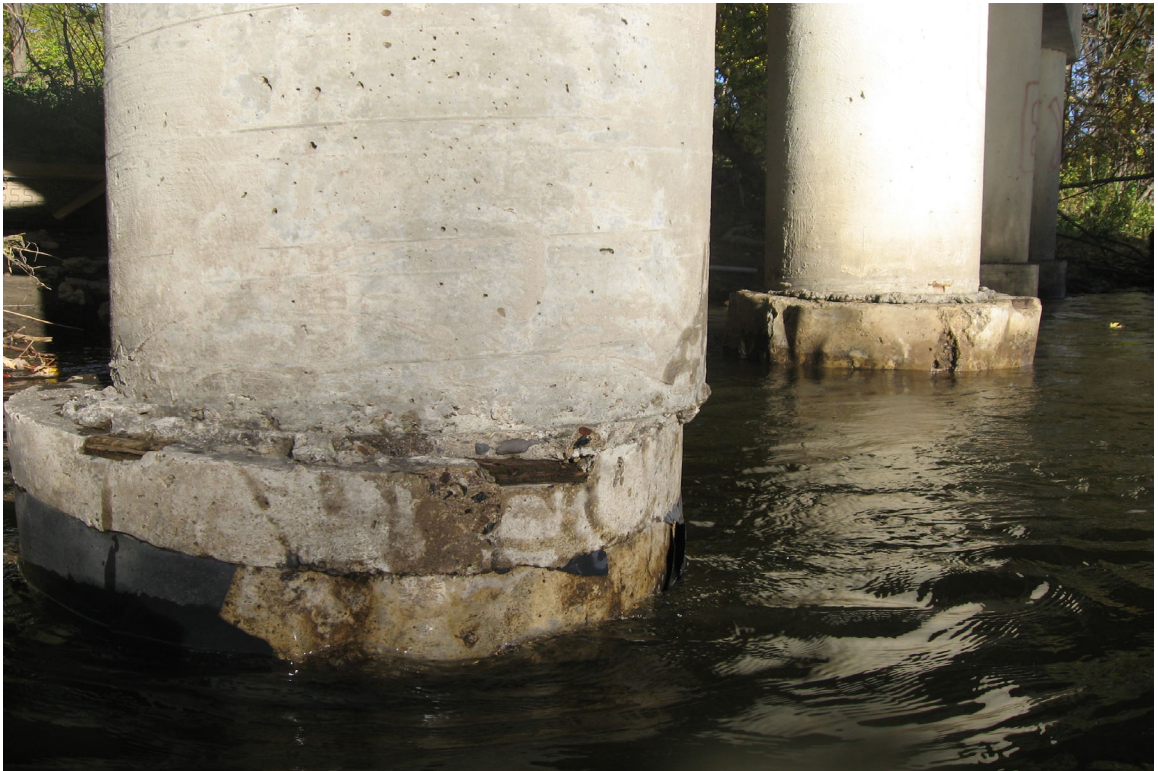
Photograph 4. View of the irregular concrete encasement at the upstream column at Pier 2, Looking Northwest. Note inconsistent placement with respect to column and form boards left in concrete.

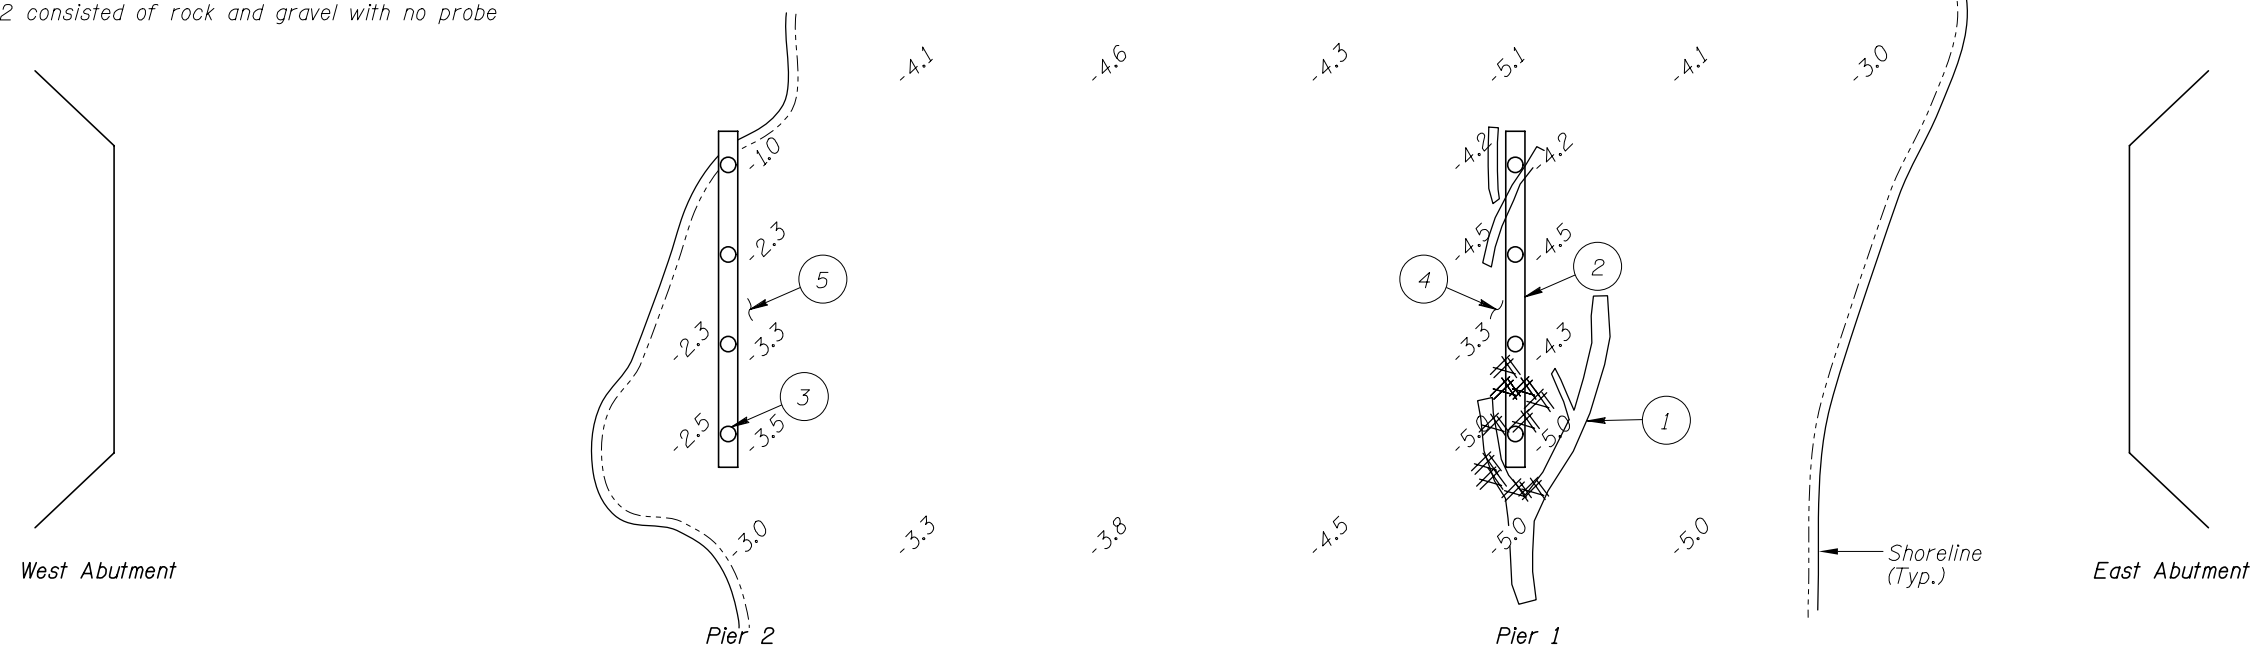
**INSPECTION AND SOUNDING PLAN**

- 2 The tops of the concrete encasements at Pier 1 were located approximately 6 inches below the waterline. The encasements varied in thickness from 1 to 6 inches with respect to the face of the columns and exhibited form irregularities (embedded form boards) with up to 3 inches of penetration.

- 4 The channel bottom at Pier 1 consisted of bedrock at the upstream and downstream columns with up to 2 inches of gravel and soft silt infilling along the middle columns. Minimal probe rod penetrations overall.

- 5 The channel bottom at Pier 2 consisted of rock and gravel with no probe rod penetration.
